# OPTIMISING THE CONTACT QUALITY BETWEEN CONTACT STRIPS AND OVERHEAD LINE

Tramway in Oostende, Belgium. March 2008

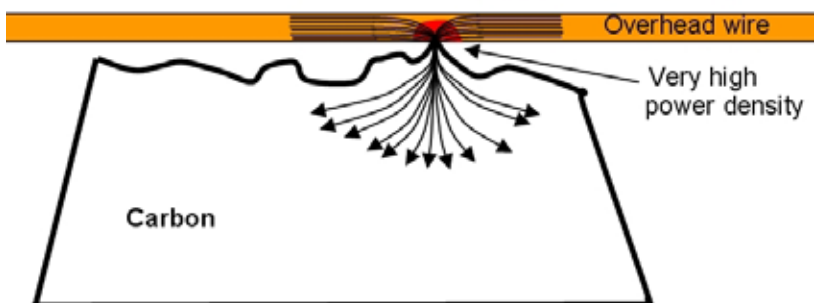
Figure 1: High current density at the last remaining contact point.

Contact surfaces are subject to wear due to force impulses, friction and power transmission. A very large proportion of the wear is caused by poor electrical and mechanical contact during power transmission. This generates electrical arcs between the wire and the contact strips. At the top of the electrical arc, material melts on the surface of the copper wire. At the other end, carbon material gets burned. But even without an electric arc, there can be high material loss. In the case of a borderline contact interruption, the current density increases in the last remaining contact points. There is so much energy being passed through these points that it gets transformed into heat and the overhead copper wire starts melting. This melting contact condition is shown in Figure 1.

Due to the high current density and heat, the molten copper gets abruptly sprayed and deposited in the pores of the carbon and on the contact strip.

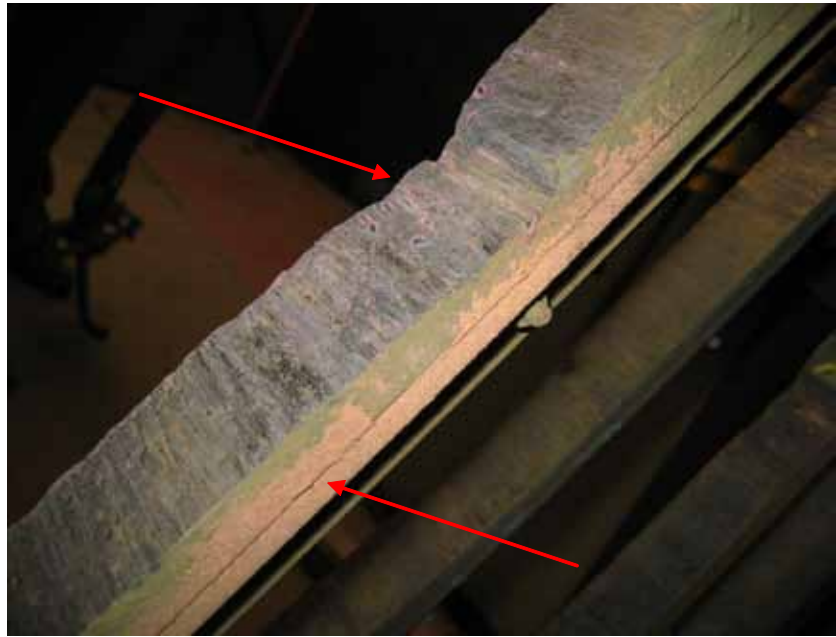
Figure 2: Contact strip with grooves and copper deposit

A damaged contact strip is shown in Figure 2.

Copper deposits can be seen on the contact surface and on the side of the carbon piece. In addition, the carbon body is damaged by grooves caused by insufficient wire stagger or an overload of the carbon section.

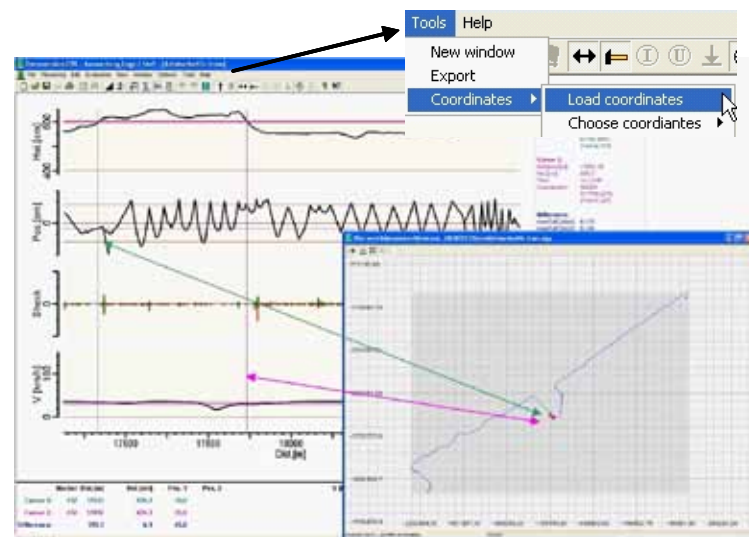
Figure 4: Measurement chart and course angle

Figure 4 shows an overhead wire measurement chart and the corresponding route. From top to bottom, the chart displays the overhead wire height and the stagger, the pantograph shocks, and the tram's speed. Other data can be added or filtered out to assist in the analysis.

You can see the cursors located at the 17,534 m and 17,894 m positions (the beginning of the route being 0) and in the separate graph for the route, there are two colored points which mark the corresponding GPS co-ordinates.

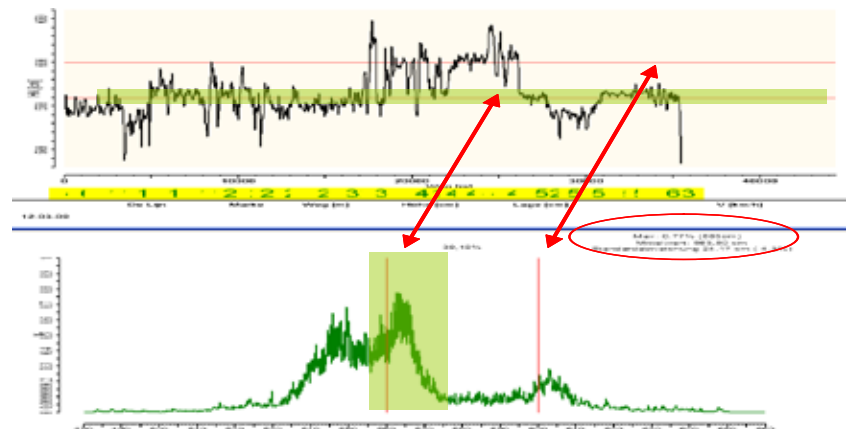
Figure 5: Height of overhead line and corresponding distribution curve

DTK's software allows you to stretch or compress charts or display selected curves and hide all other values. For example, if only the overhead wire height is displayed (See Figure 5), then the chart shows that:

- The overhead wire height is outside the limits of the allowance area (marked in green);
- The height's standard deviation is very high (24.17 cm or 9.52 in); and
- The rate of rise and decline of the overhead wire is very steep.

Such characteristics often result in insufficient electrical contact between the overhead wire and the contact strips.

Figure 5 shows the height profile of the overhead wire on top and its corresponding distribution below. The average overhead wire height is 563.80 cm. With a value of 24.17, the standard deviation is very high.

The height is over 6.5 meters for 1.700 meters of the route. Most of the time the overhead wire's height is 5.64 m.

Below we will show that in this particular case the customer should first try to reduce the weight of the pantograph's head. Moreover, we recommend a reduction in the changes of contact wire gradients as far as possible and adjustment of the contact wire height so that it complies with the nominal value.

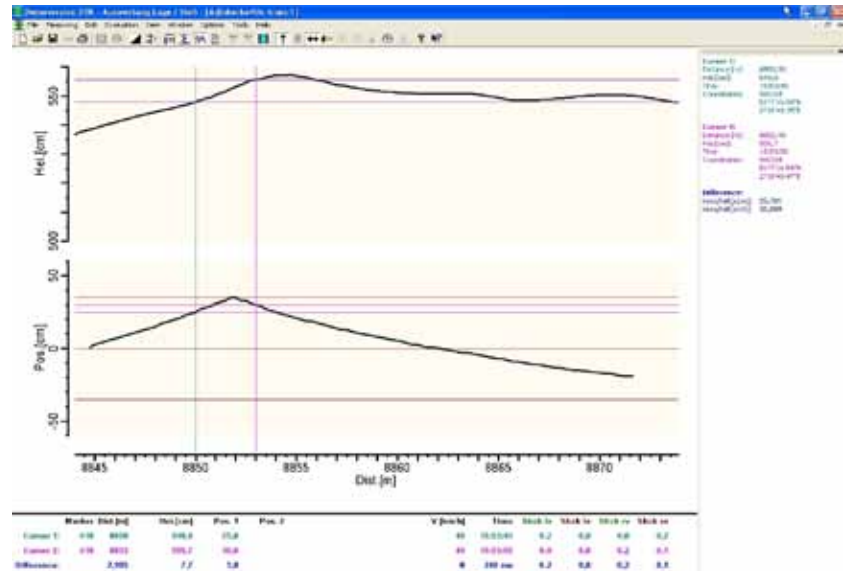
Figure 10: Chart for the first row of the spreadsheet (Figure 9)

With a double click on the spreadsheet's first row, the software will display the corresponding route section in a chart. Figure 10 shows the graph for this section. Considering the vehicle speed of 45 kph, the pantograph has to change heights at an average speed of 32.009 cm per second. At the position of the second cursor the overhead wire is 7.7 cm higher. The distance between both cursors is passed through in 240 ms. The diagram also shows a clamp at +35 cm. The coordinates for both cursors are displayed on the right hand side of the chart. A click on the film icon will start the corresponding video sequence.

The pantograph test results show that such a steep rise of the overhead wire disturbs the contact between contact strips and overhead wire, which creates the problems described earlier in Section 3 of this article.

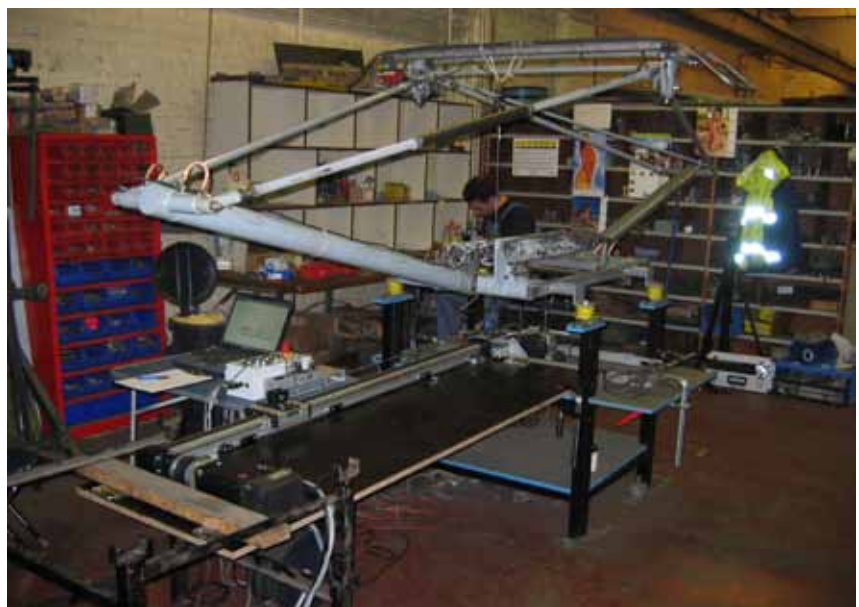
Figure 11: Pantograph with DTK's contact force measuring equipment

Figure 11 shows the pantograph analyzed with DTK's equipment.

To develop a contact force profile of the pantograph, its contact force is measured at different simulated conditions. The DTK test fixture controls a servo motor to simulate OHL rate of height changes. One end of a cord is fixed on the linear bearing and the other end is connected to a force sensor that is fixed on the contact strips (or on a piece of overhead wire lying on top of the contact strips). The linear bearing allows the pantograph to move downward.

During this motion, the central spring force presses the pantograph against the overhead wire. The overhead wire is pushed upwards with a certain speed.

During this motion, the force sensor measures the pressure between contact trips and overhead wire. The software changes the rise and fall of the pantograph in double steps of 2 to 30 cm per second. The pantograph's whole working range is divided into steps of 10 cm. After the 10th cm, the motion stops for 5 seconds.

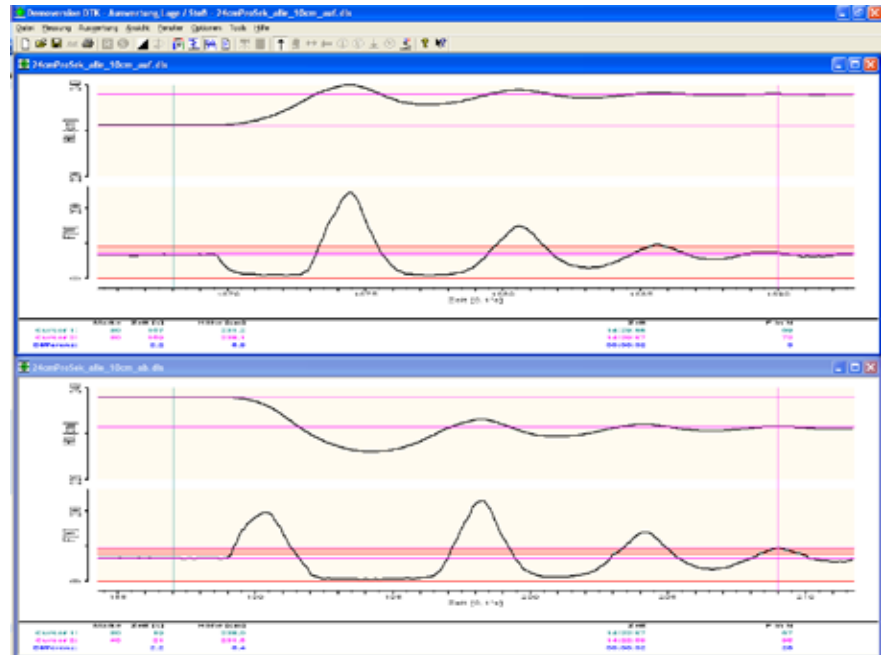
Figure 12: Pantograph monitoring at a speed of 24 cm per second

Figure 12 shows the contact force measured during a rise or decline at a speed of 24 cm per second. From top to bottom it shows the curve for the pantograph height (at a simulated overhead wire rise), the corresponding curve for the contact force, the curve for the simulated overhead wire fall, and the corresponding contact curve.

The pantograph's working height is 210 cm. This chart shows that at a rise or fall speed of 24 cm per second the tested pantograph can not follow the changes in height of the overhead wire.

The contact force between contact strips and overhead wire drops to a value of 0 Newton for a longer time. Under such conditions, if the vehicle needs current in order to accelerate, the problems described

earlier in Section 2 will occur, e.g. as electric arcs.

Thanks to the results of the pantograph analysis, DTK's system can define the maximum vertical speed the pantograph will need in order to maintain a sufficient contact between the contact strips and the overhead wire. The operator now has three options at its disposal to eliminate this condition: Change the rate of rise/fall of the OHL. Reduce the normal speed of the trains's operation in these sections. And/or modify the dynamic response of the pantograph.

This is a decline of 62.66 percent. The pantograph has to follow this change in height at a rate of 30.148 cm per second. The pantograph curves (previously shown in Figure 12)

show that the pantograph already loses contact with the overhead wire at a rate of 24 cm per second.

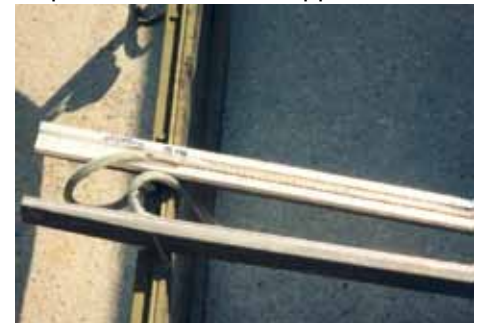
Figure 13: Contact strips

with an integrated copper cable, which is brazed in their bottom side. The contact strips are held by clamps made of stainless steel. These clamps are insulated against the carbon strips, so that no electric arc can affect them if there is insufficient electrical contact. As a result, the contact strips are relatively stable, given the poor contact conditions.

Figure 13 shows the special carbon strips with the brazed copper cable.

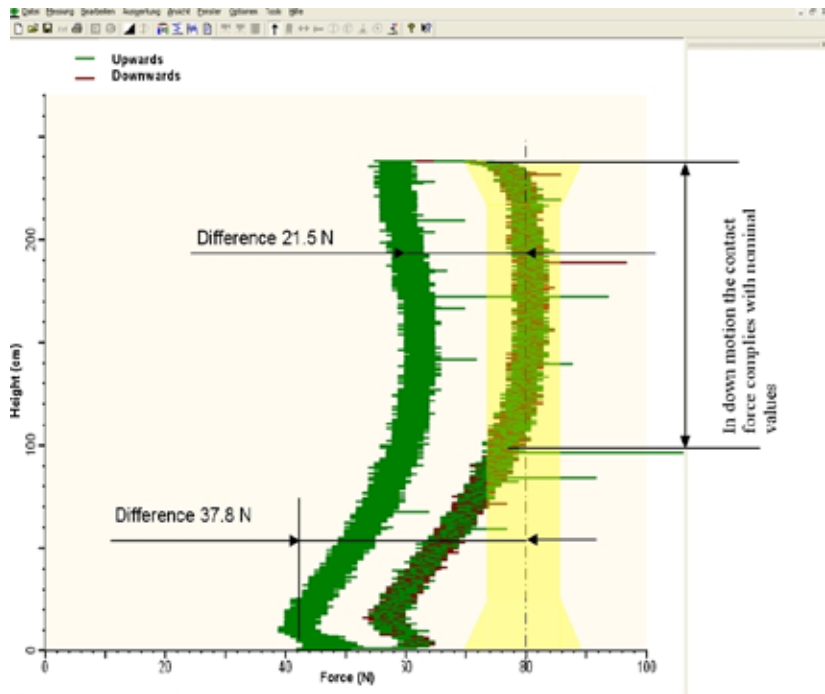
Figure 14: Pantograph response curve

The pantograph's response curve also shows the heavy mass of the pantograph's head. The response curve is obtained by moving the pantograph upward and downward over its complete operating range at a very slow rate of change (0.3 cm per second). Figure 11 shows a pantograph with DTK's system installed. During the up and down motion, DTK measures the contact force continuously and displays the recorded values in an xy chart called a response curve.

The response curve of Oostende's pantograph is shown in Figure 14. The nominal range the contact force should comply with is marked in yellow. The chart shows that the contact force stays within the nominal values during downward motion between a working height of 2.30 m and approx. 1.00 m. Below this level in downward motion and over its complete working range upwards, the contact force does not comply with the nominal range. The highest discrepancy is 38 N below the pantograph's nominal value. At this point the remaining force of the contact strips is only 42.2 N. The average contact force in up and down motion differs by approx. 21.5 N. In the case of lighter pantograph heads, both curves would be much closer to one another.

This pantograph is not able to follow even rather small contact wire gradients. The head mass it has to move, and consequently its inertia, are too high. The result is contact interruptions as shown in Figure 14.

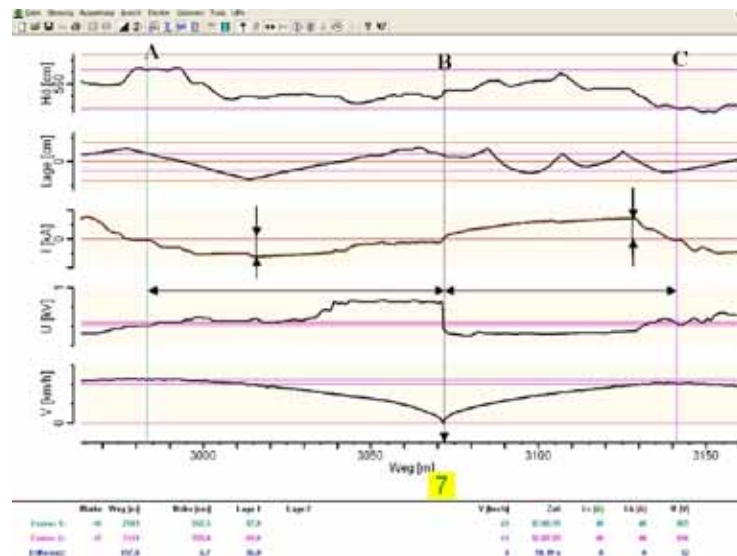
Figure 15: Measurement chart

Figure 15 shows (from top to bottom) the contact wire height, stagger, current transmitted through each contact strip, voltage, and the vehicle speed.

The x axis represents the distance. DTK measured the individual amperage for each strip, regardless of whether the current was consumed by the vehicle or returned to the overhead wire in case of deceleration. The current that corresponds to the front contact strip displays in brown, while

the green curve corresponds to the rear contact strip. The software can also summarize both curves as one total current value. In this chart, three locations have been set with letters: "A" at position 2983 m, "B" at 3072 m and "C" at 3141 m. Along the route between A and B, the vehicle has decelerated until at a full standstill. The return current, which is shown where the curves are below zero, causes an increase in voltage.

The vehicle takes off and accelerates between the positions B and C. While doing so it consumes current that is shown in the curves above the zero line. The current consumption results in a decrease in voltage. In addition to this, the voltage can be affected by other vehicles driving along the same power section, either consuming current or returning part of it to the overhead wire. But the voltage won't oscillate even in this case.

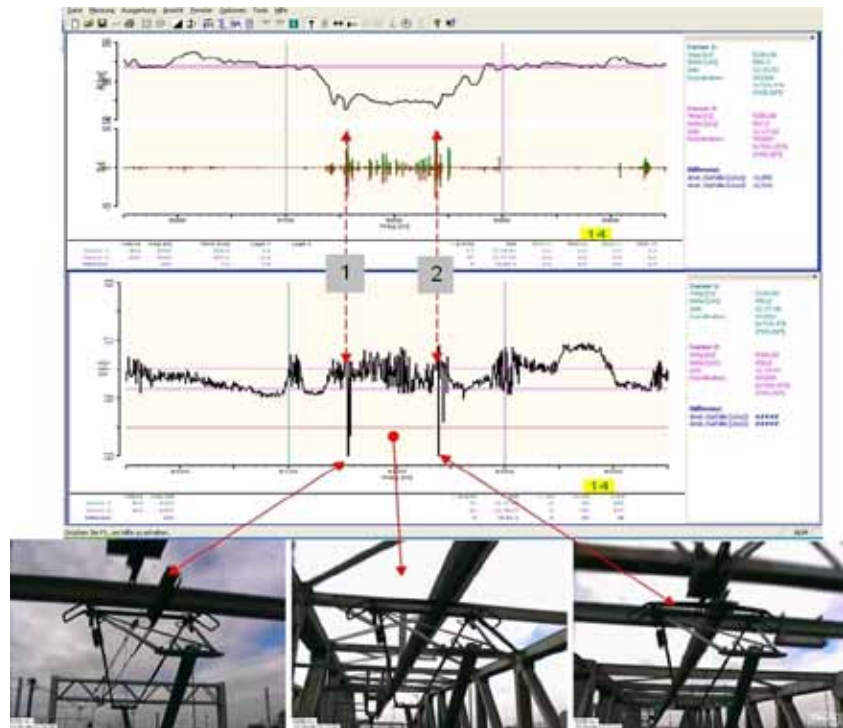
Figure 16: Insufficient contact between contact strips and power rail

Figure 16 shows (from top to bottom) the contact wire height, shocks between contact strips and overhead wire, and the voltage on this route section. Any other available chart has been hidden for clarity. Along the route between the two cursors, the chart shows a strong variation in voltage. At the positions "1" and "2", the voltage collapses for a short while. The synchronized videos show a power section change that is caused by a bridge at the harbor entrance. In this specific instance the entire bridge, including track and power supply, can be lifted and put aside if required.

On the bridge, the system consists of a rigid power rail situated above the train. You can observe more shocks on this route section. These shocks disturb the contact quality between contact strips and power rail. On another bridge situated at a harbor entrance, an overhead wire was installed instead of a power rail. This section is displayed in Figure 17. The pictures displayed under the chart were generated out of the corresponding synchronised video. Since an overhead wire is used on this bridge, the current collecting system remains elastic. That is why there are fewer shocks between

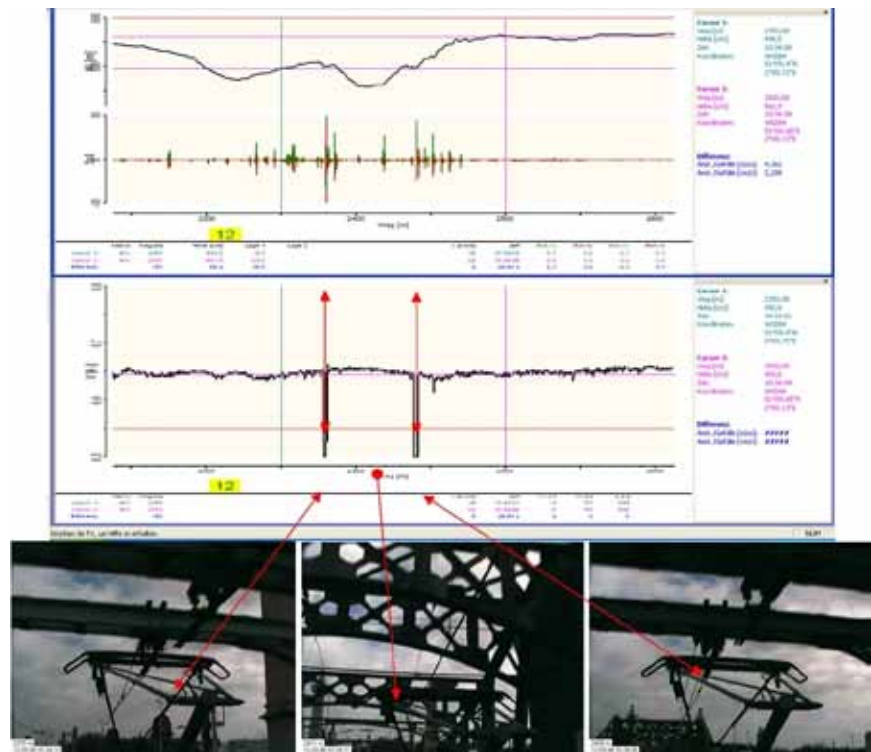
Figure 17: Good contact between overhead line and contact strips on a bridge

contact strips and overhead wire than on the similar section using a power rail. The electrical contact between the contact strips and overhead wire is better on this route section. Thus, the overhead wire voltage varies considerably less.

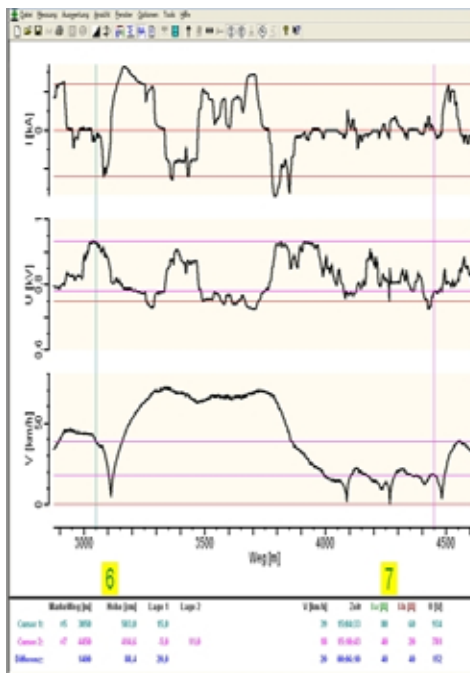
Figure 18: Sufficient contact

routes. Figures 18 to 20 show the consumed and returned current, measured voltage, and the speed for different current collection systems. All other values are hidden.

The curve for voltage in Figure 18 shows no short time oscillations. The variations are influenced only by the vehicles taking or returning current among the same power section. In Figure 19 and especially in

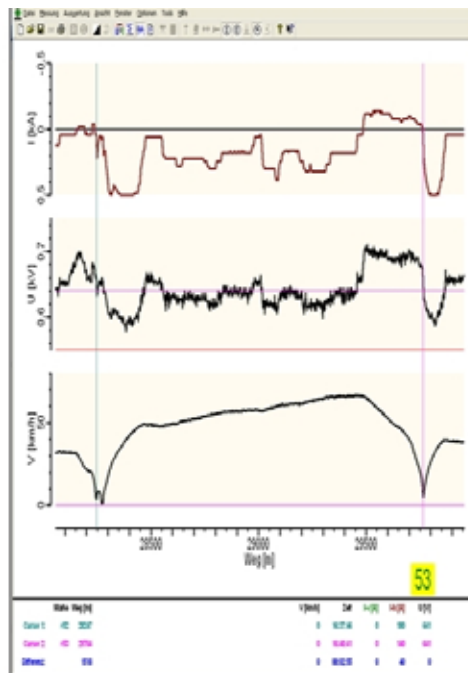
Figure 19: Insufficient contact

Figure 20, the measured values oscillate very strongly.

These oscillations are predominantly caused by the discontinuous contact between overhead wire and contact strips. The corresponding video sequence shows the pantograph's run.

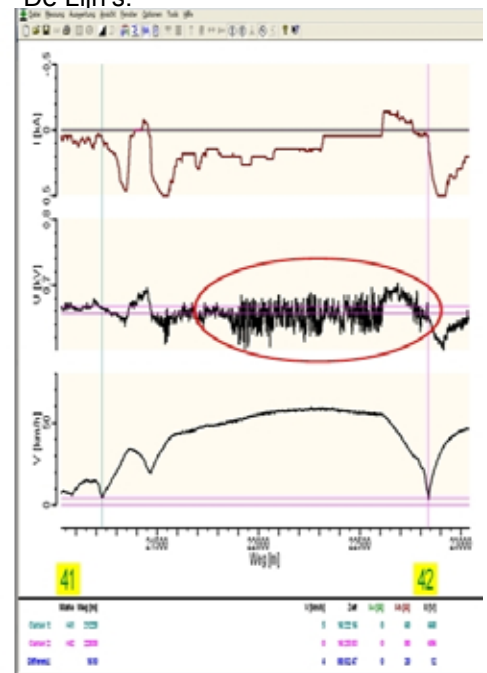
Figure 20: really bad contact

Oscillations similar to those displayed in Figure 20 occurred several times during the survey at De Lijn's.

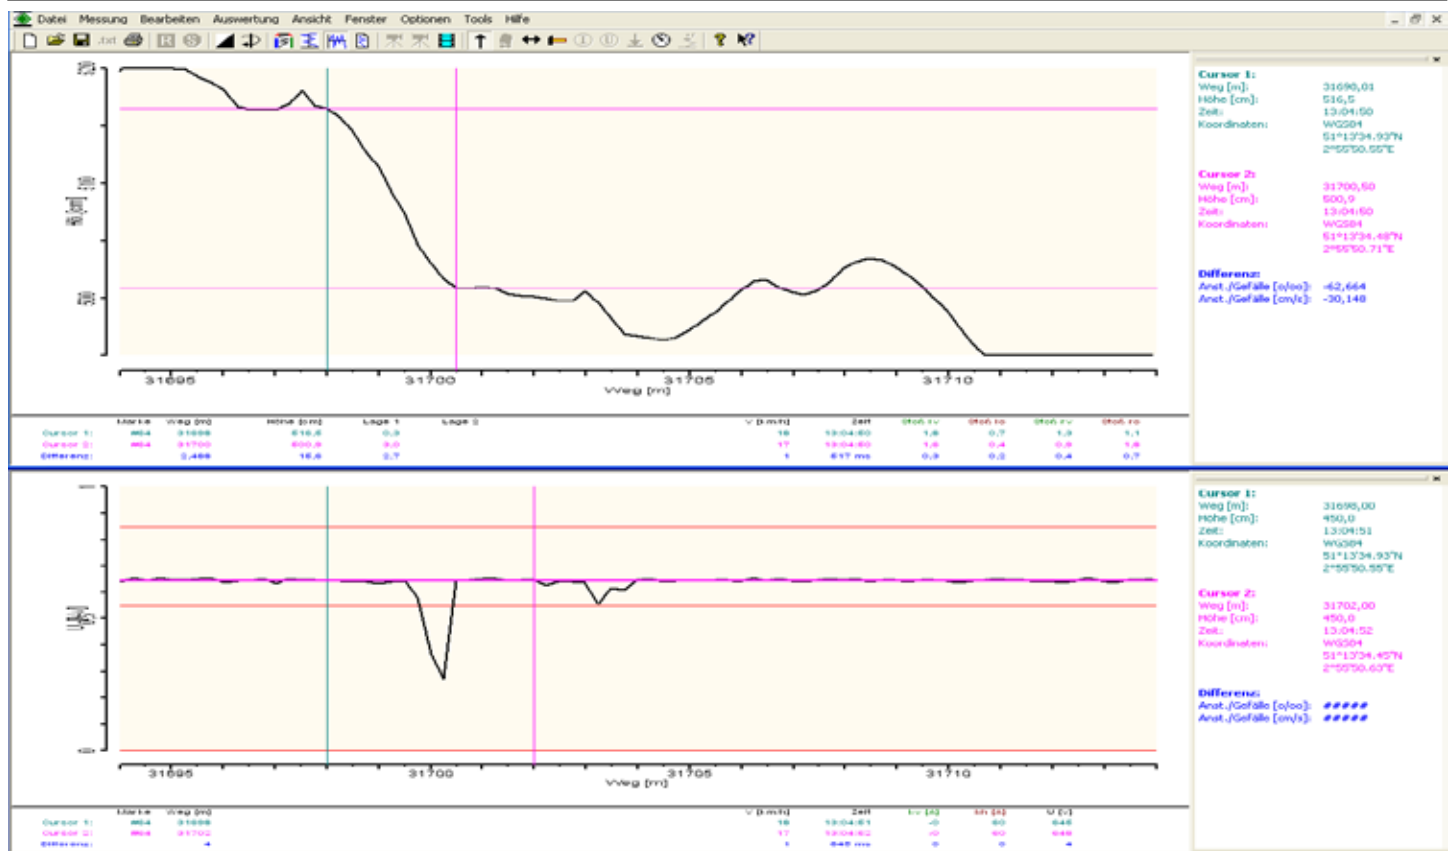
Figure 22: Interruption in contact

The bottom chart in Figure 22 (on the following page) shows the result of the overhead wire decline: the voltage collapses and the contact strips lose contact with the overhead wire.
